**PRELIMINARY INVENTORY
and
ASSESSMENT REPORT
of
Lewiston Lower Branch Rail Corridor**
Lewiston/Lisbon, Maine
September 14, 2018

Prepared for:
Lewiston-Auburn Railroad Company

SEBAGO
T E C H N I C S
CIVIL ENGINEERING • SURVEYING • LANDSCAPE ARCHITECTURE

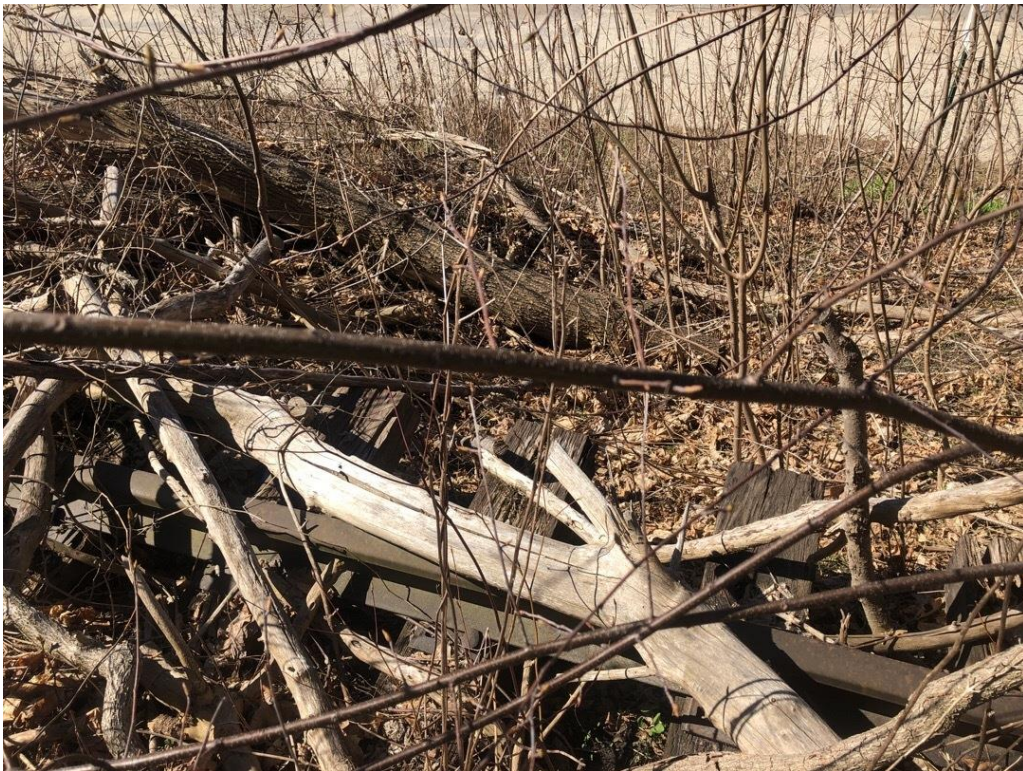
Photo 1. – behind Lepage Bakery facility

Medium severity erosion beneath rail.

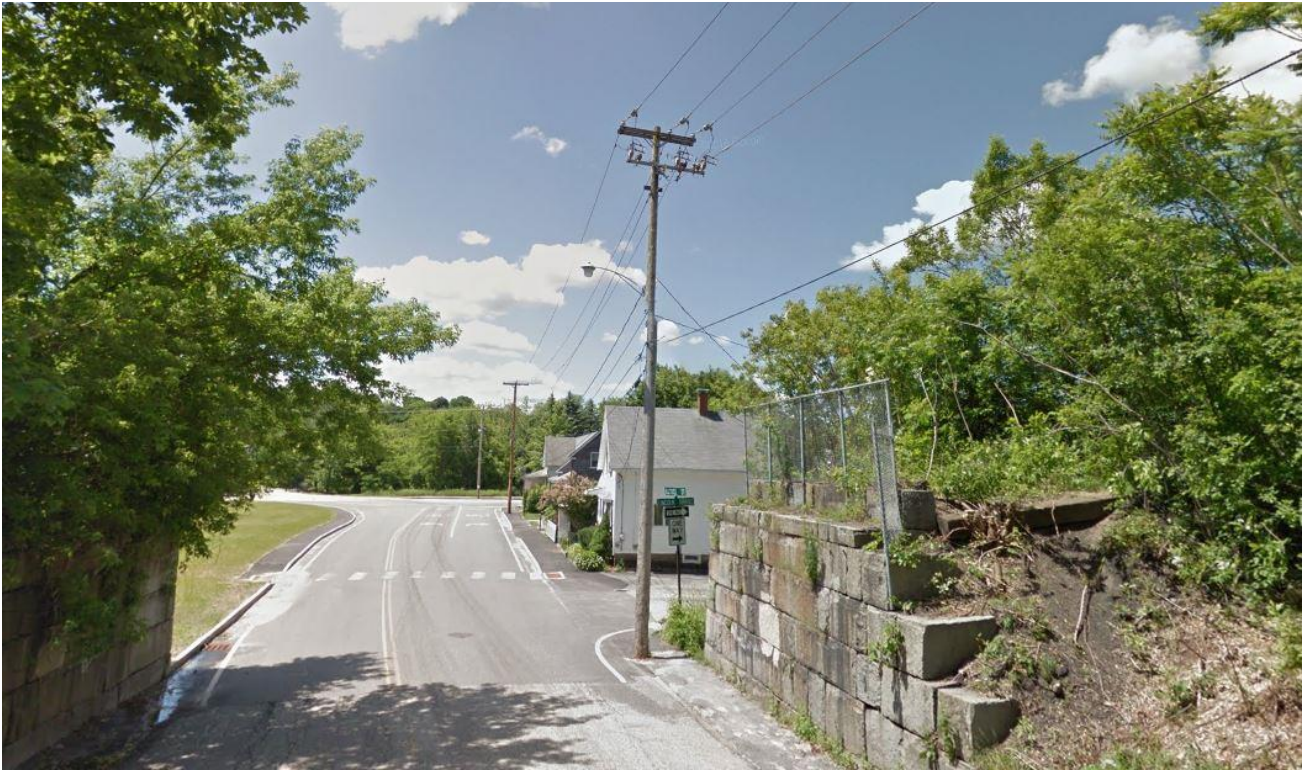
Photo 2. Locust Street

Locust Street – The intersection of the corridor with Locust Street is marked by the absence of the original railroad bridge. A replacement structure would need to be constructed to permit above-grade crossing. Pedestrian or bicycle access to Locust Street at this location would be difficult and costly.

Locust Street – The bridge that used to cross Locust Street was a significant steel girder structure. Originally spanning approximately 50'-60', it was removed in the early 1990's due to its height being a safety hazard for tractor trailer truck traffic on Locust Street. The large granite block abutments are in good condition, however, may require repointing for structural stability. The top of each abutment is overgrown with small trees and brush and would need to be cleared.

Removed bridge on Locust Street. Height of new structure would be a concern.

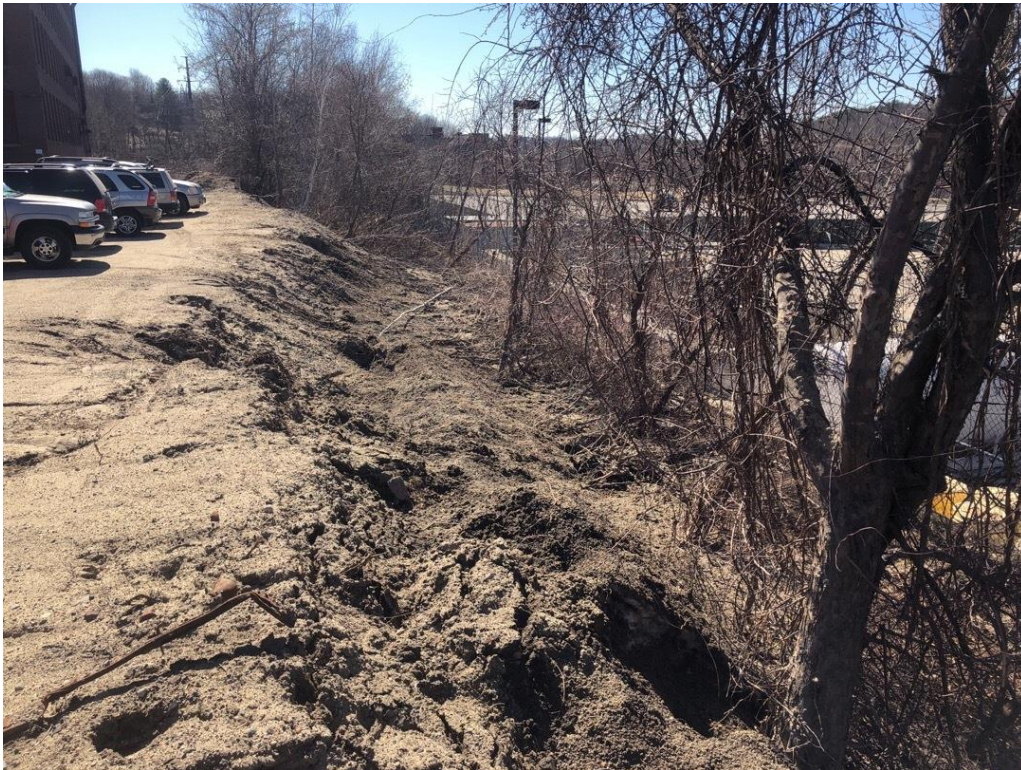
Photo 3. – Beside Marden's Distribution facility

Severe erosion and overfill from the Marden's Distribution Center parking lot on Locust Street accumulating on rail. A retaining wall may be necessary.

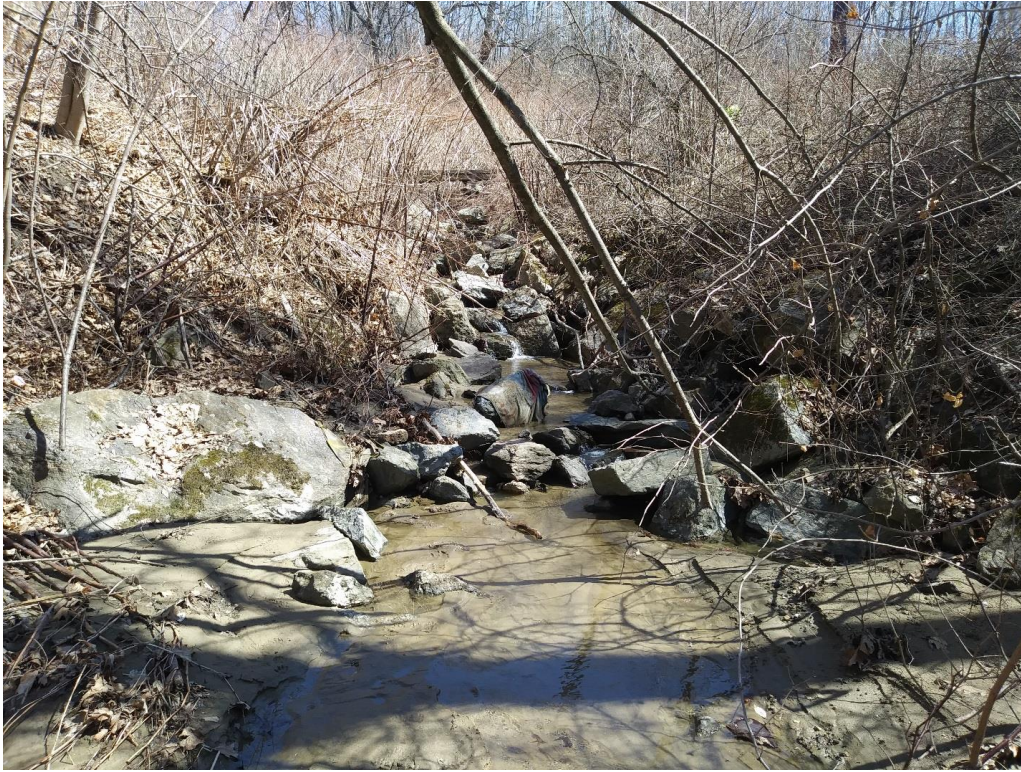
Photo 4. Promenade Ravine

Promenade Ravine – SW of the Promenade Mall the railroad crosses a deep ravine with an elevation change of 30'+/-. The railbed is non-existent for approximately 500 l.f. No bridge structure currently exists. Depending upon final design grades the approaches to the ravine will need to be raised and a new bridge structure or large culvert will need to be installed.

Both ties and rail are absent on the steep slope leading down to this stream and floodplain.

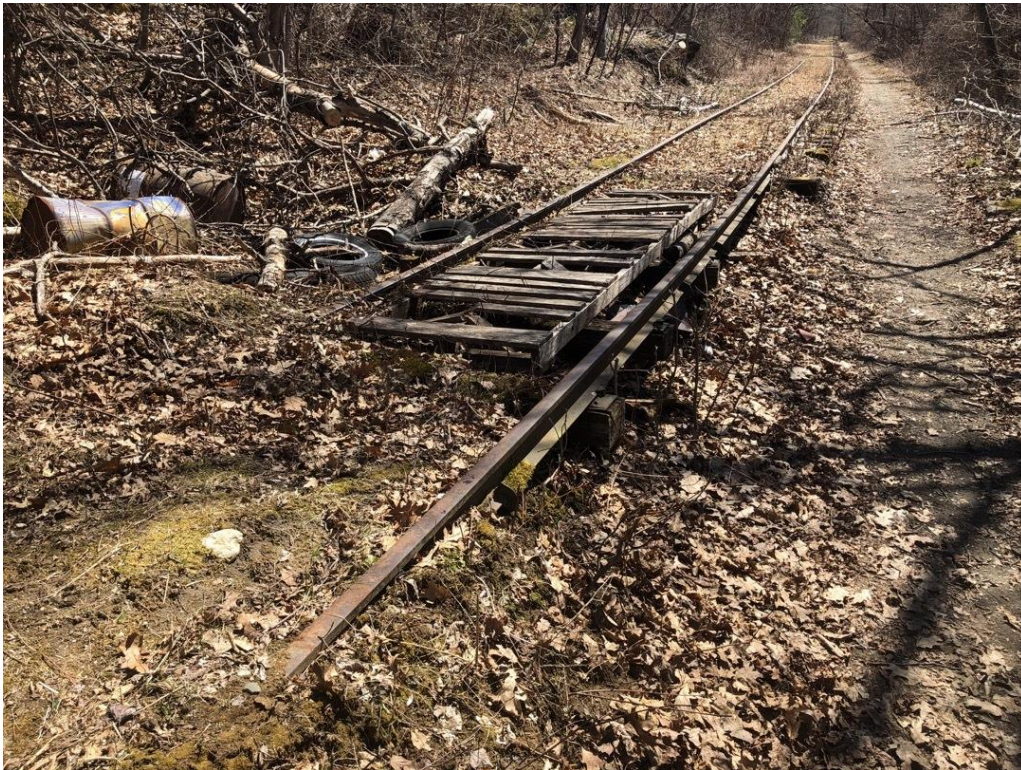
Photo 5. Approaching South Avenue

Medium severity erosion beneath rail.

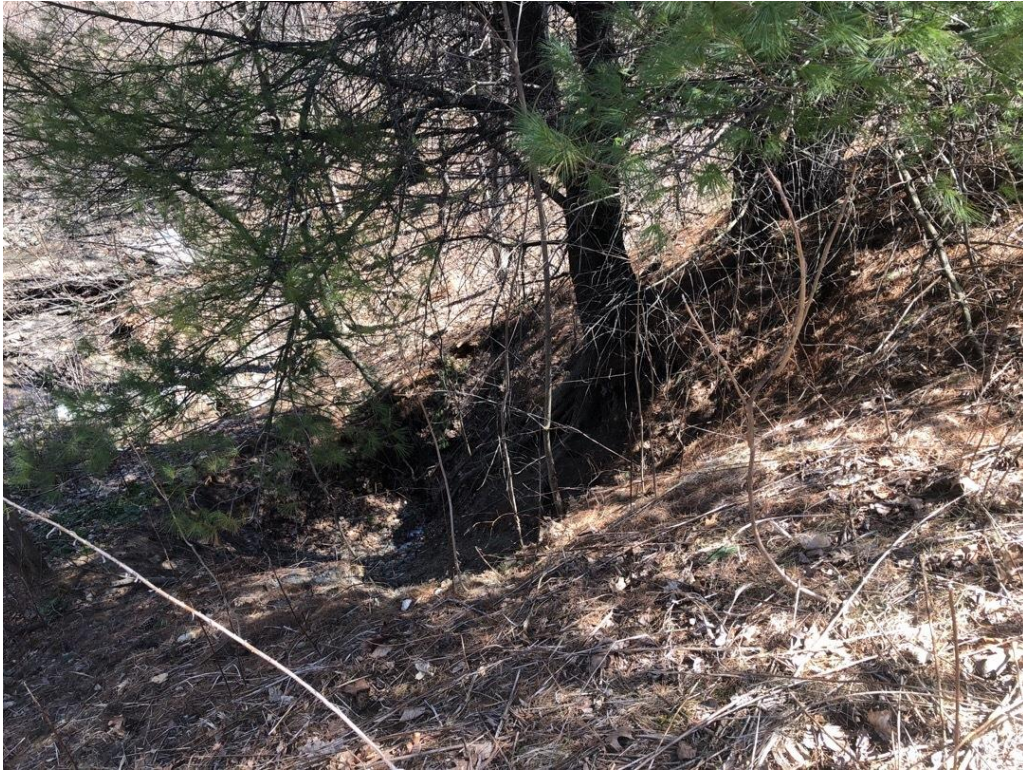
Photo 6. Near Goff Brook
Medium severity erosion on a steep slope beside rail bed.

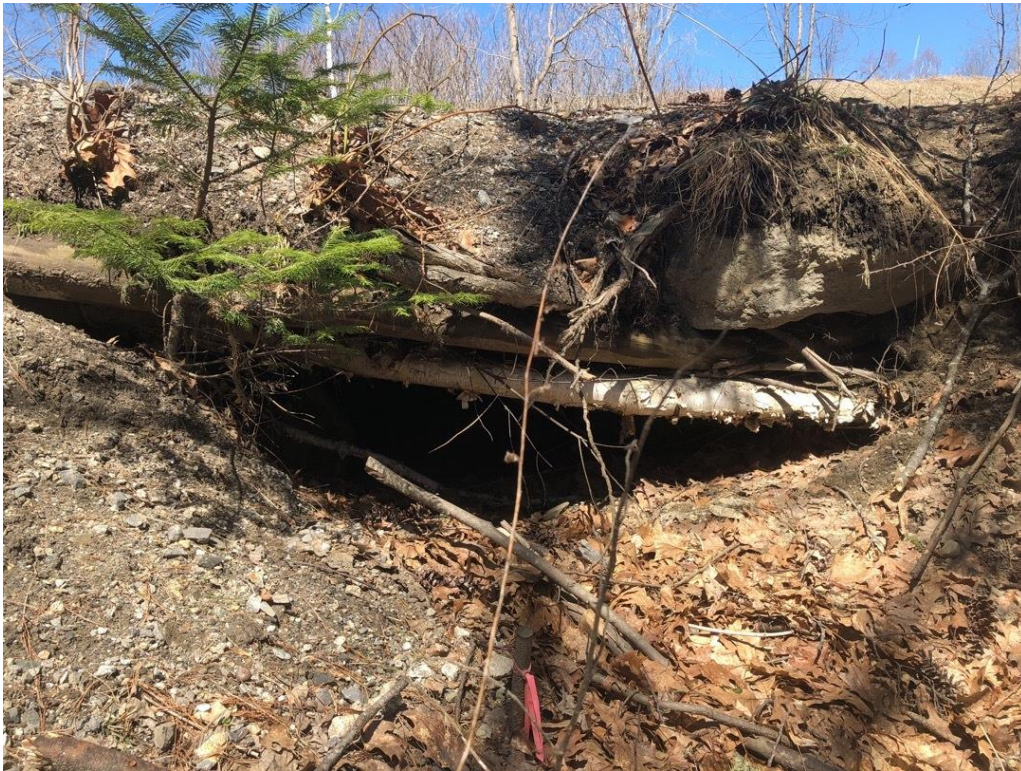
Photo 8. South of Olive Avenue
Medium severity erosion beneath rail.

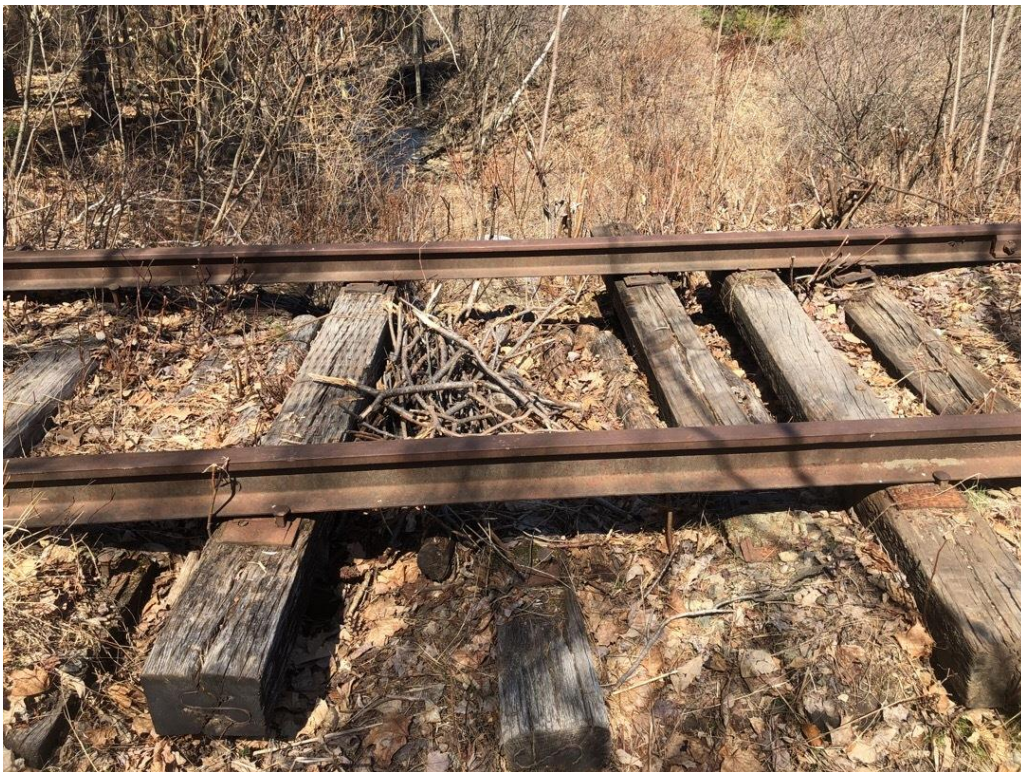
Photo 9. West of Liberty Mutual
Medium severity erosion beneath rail. Wetland and stream in background.

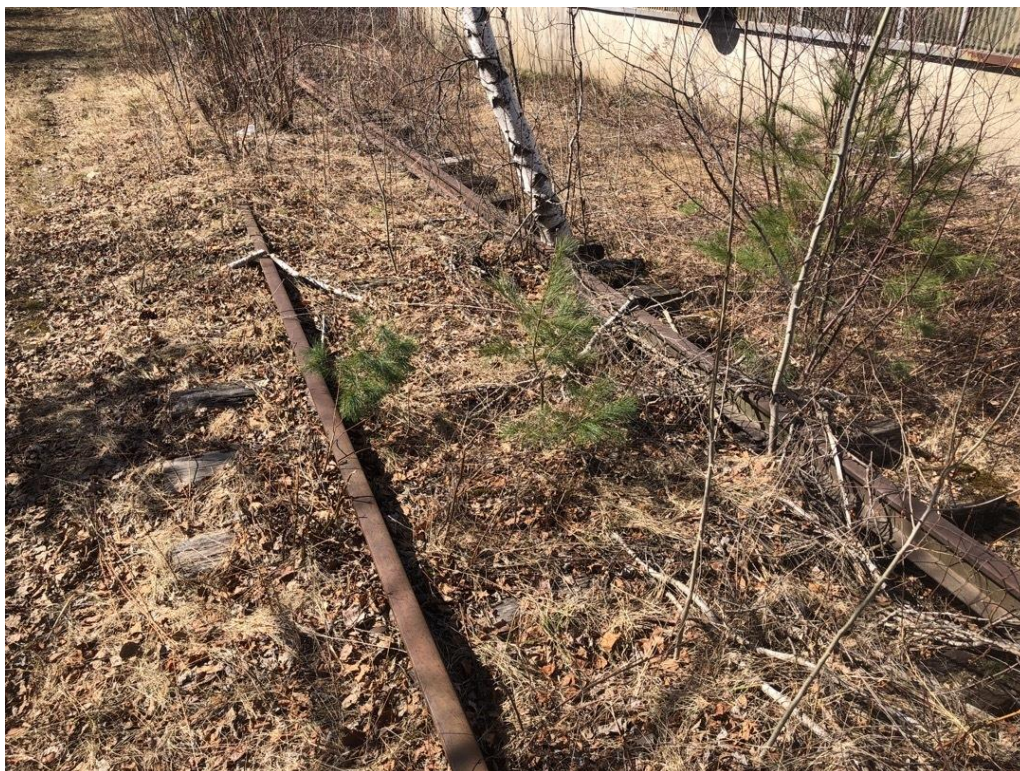
Photo 10. East of Pleasant Street
Minor erosion beneath rail. Wet area adjacent to rail.

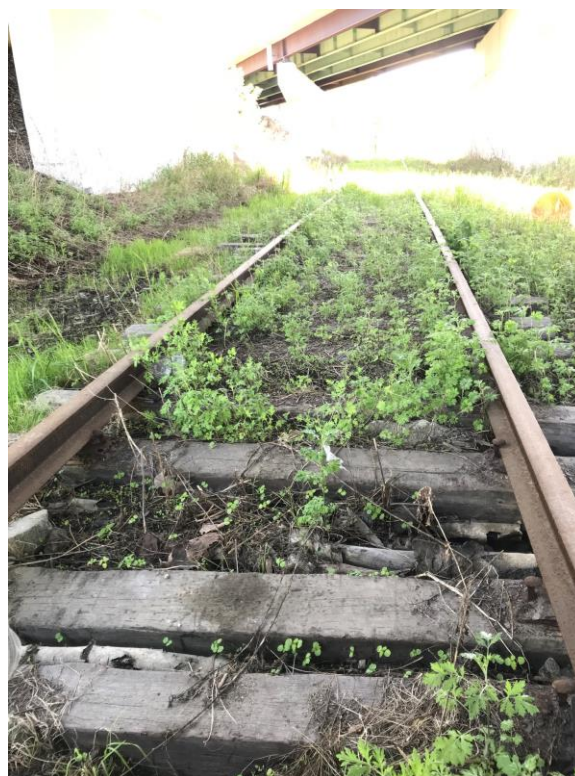
Photo 11. Near Turnpike Overpass – Rt. 196
Minor erosion beneath rail.

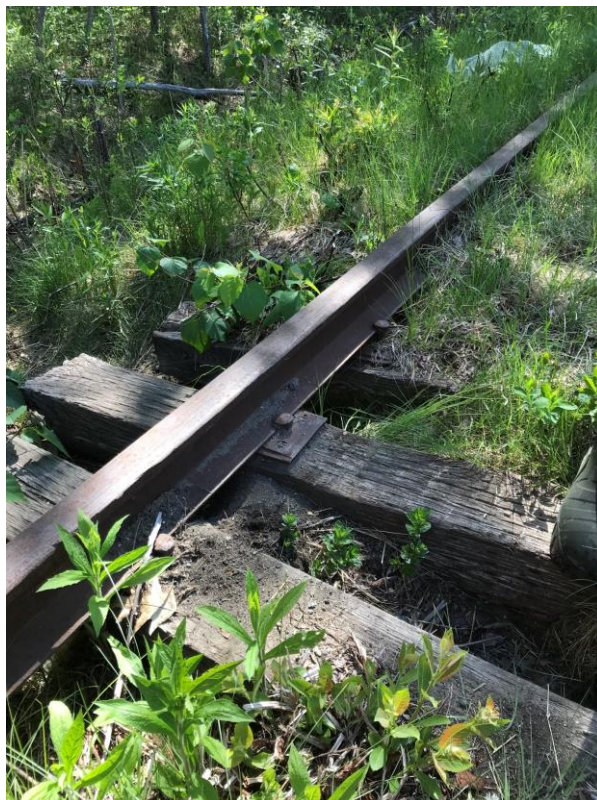
Photo 12. East of Turnpike Overpass
Minor erosion beneath rail.

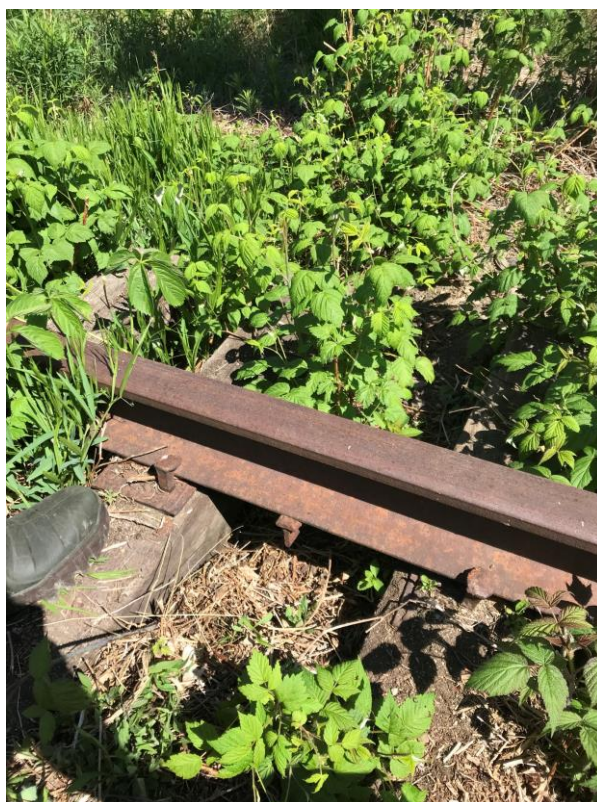
Photo 13. East of Gould Road
Minor erosion beneath rail.

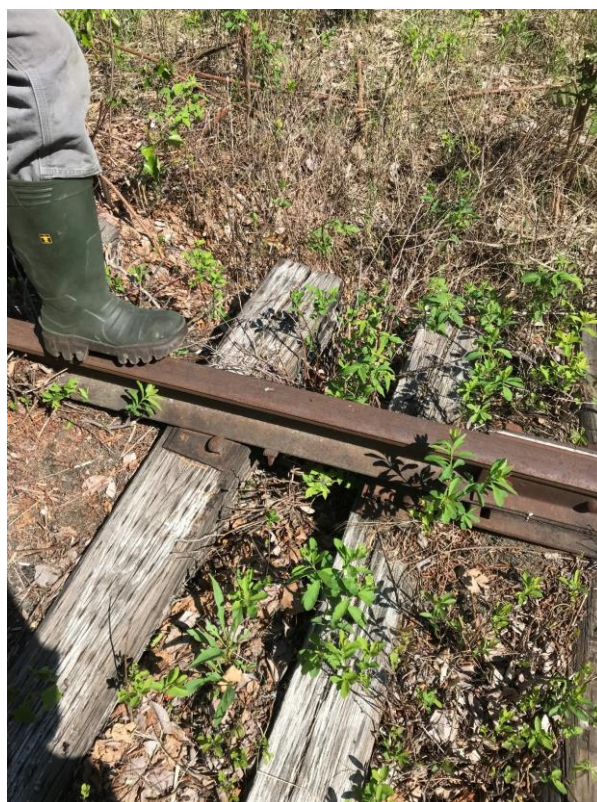
Photo 15. Near Old Lisbon Road
Minor erosion beneath rail.

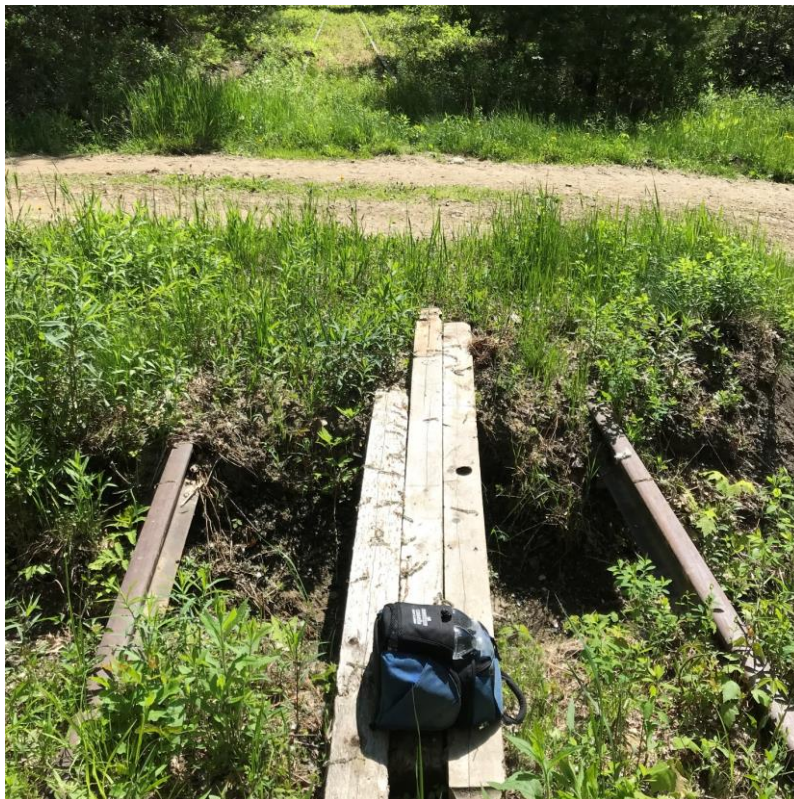
Photo 16. Between Old Lisbon and Crowley Roads
Medium severity erosion beneath rail.

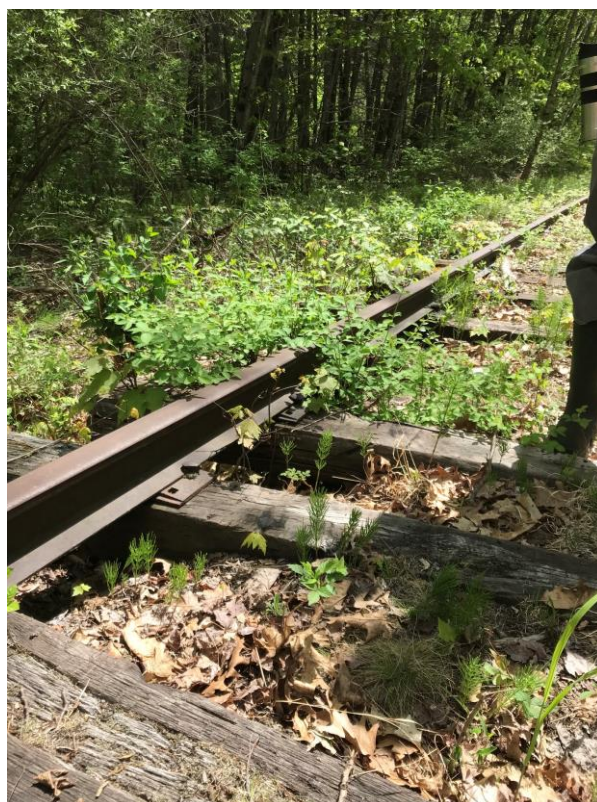
Photo 17. North of Foss Road
Minor erosion beneath rail.

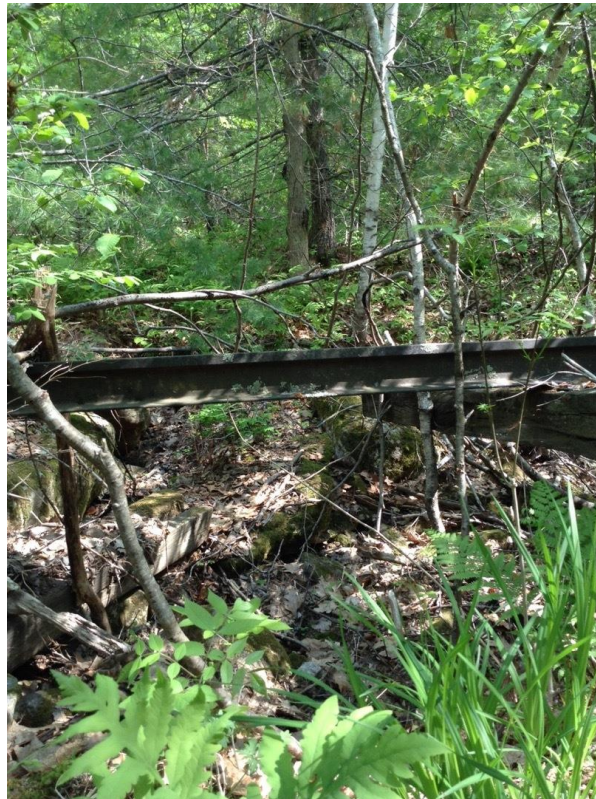
Photo 18. West of River Road, Lisbon
Severe erosion beneath rail.

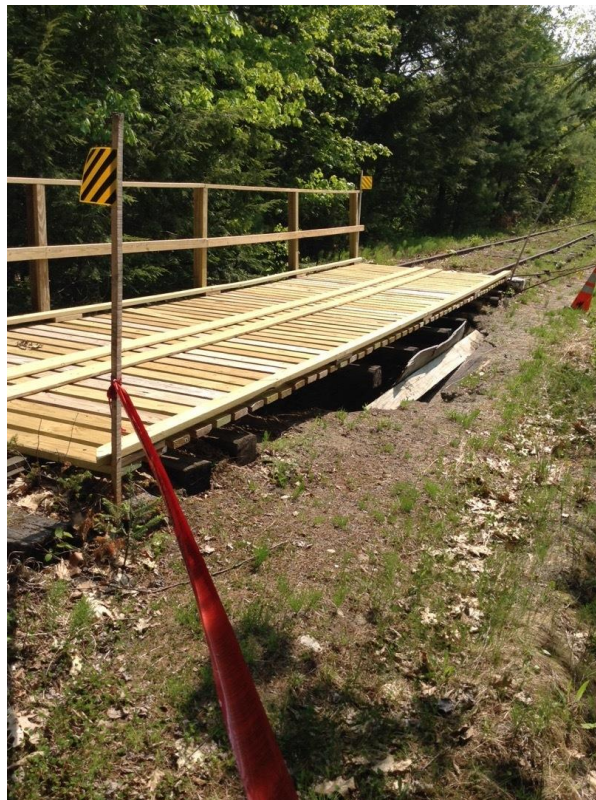
Photo 19. Near River Road, Lisbon
Severe erosion beneath rail resulted in a pedestrian bridge.

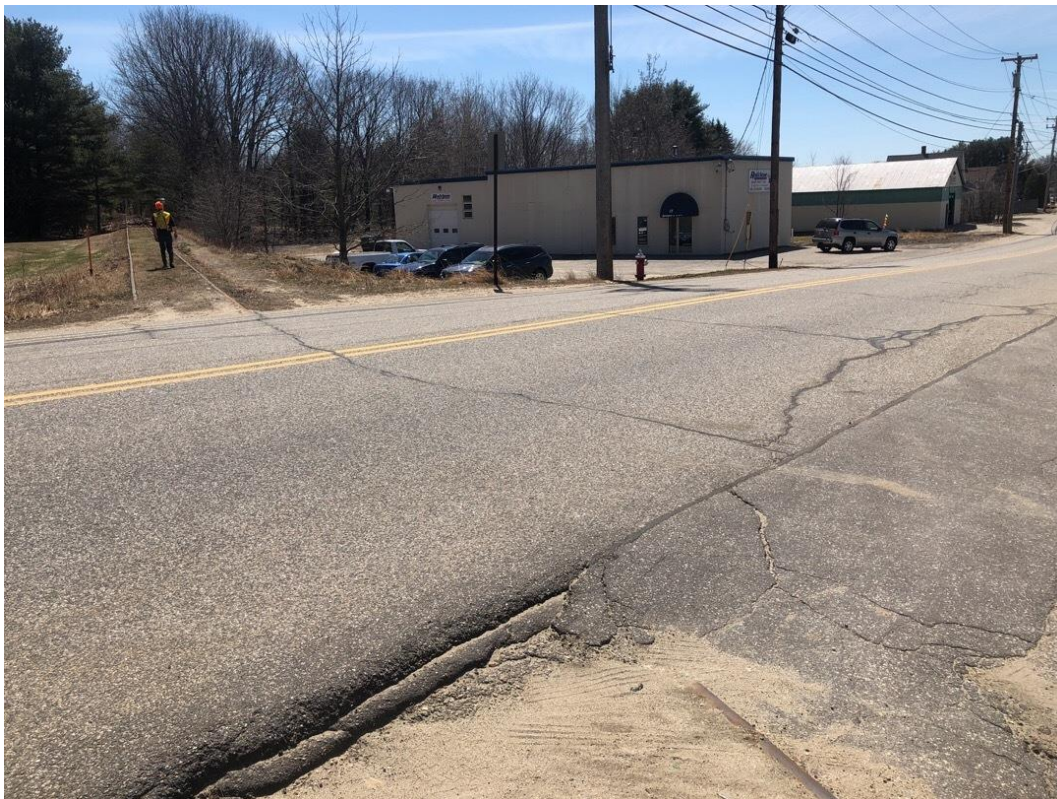
Photo 20. South Avenue Crossing.
Rail paved over.

South Avenue – The intersection of the corridor with South Avenue is wide open with good visibility both to the north and south of the rail corridor. The crossing is relatively flat and the rail appears to have been paved over or removed with the advent of roadway improvements. Future improvements would include advance signage, trail bollards and on the road markings.

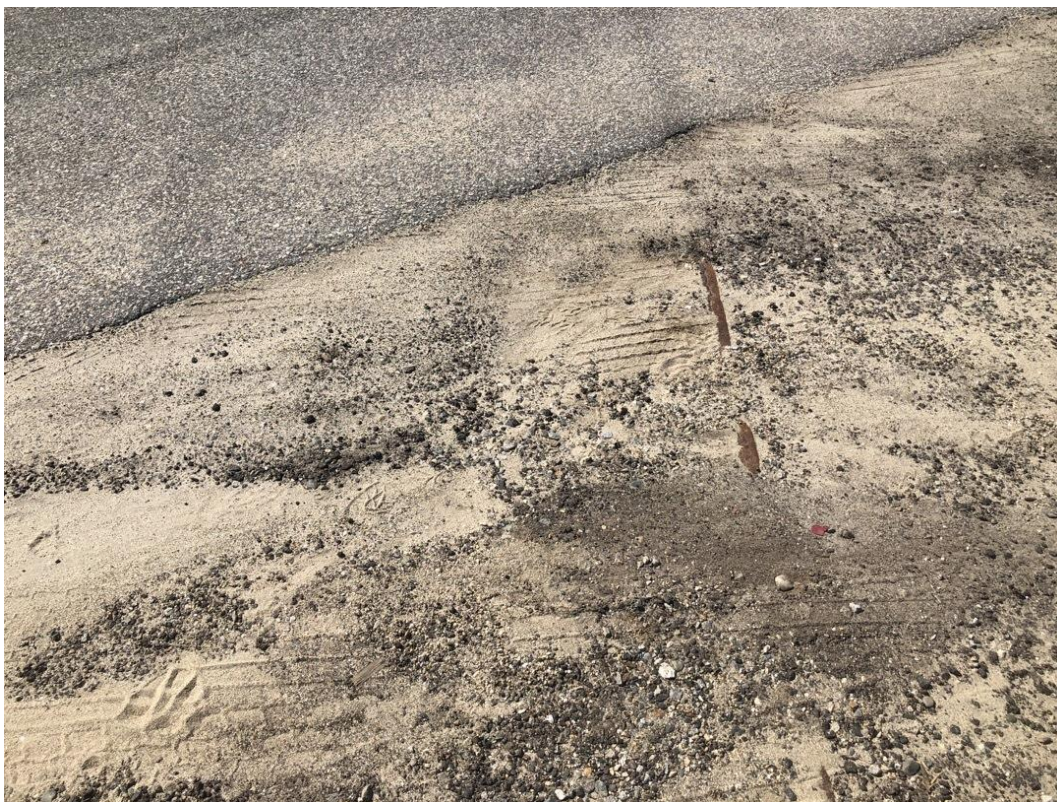
Photo 21. Pleasant Street Crossing.
Rail paved over.

Pleasant Street – The rail corridor crosses outer Pleasant Street in an area where numerous buildings were once served by rail access. The crossing has good visibility and is relatively flat. Future improvements would include advance signage, trail bollards and on the road markings.

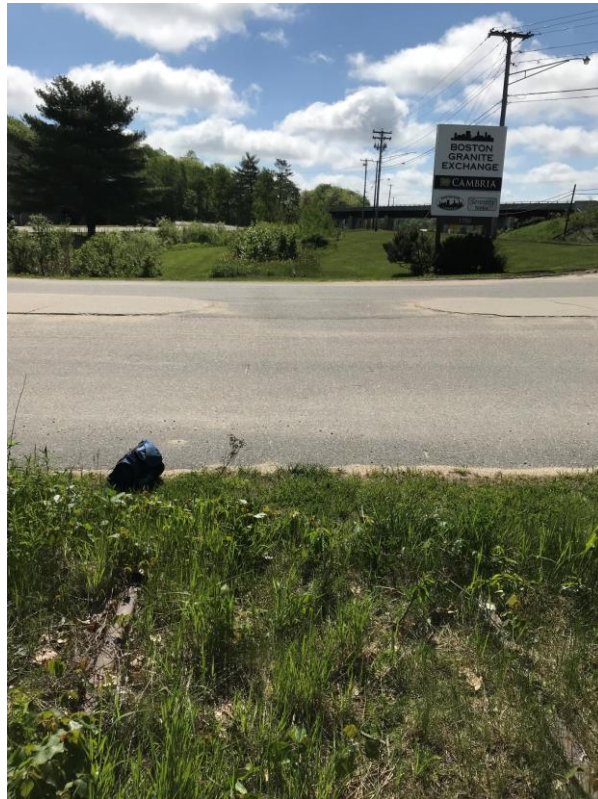
Photo 22. Driveway Crossing (Boston Granite)
Rail paved over.

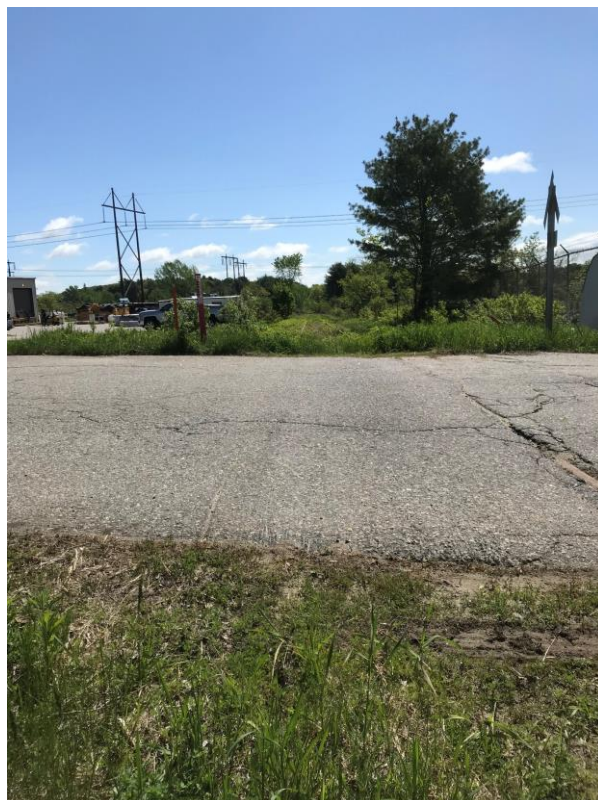
Photo 23. Gould Road Crossing.
Rail paved over.

Gould Road – Gould Road is a short roadway connecting Lisbon Street/Rt. 196 with Old Lisbon Road. The rail corridor crosses the narrow roadway at about a 90° angle in an open, visible location. Future improvements would include advance signage, trail bollards and on the road markings.

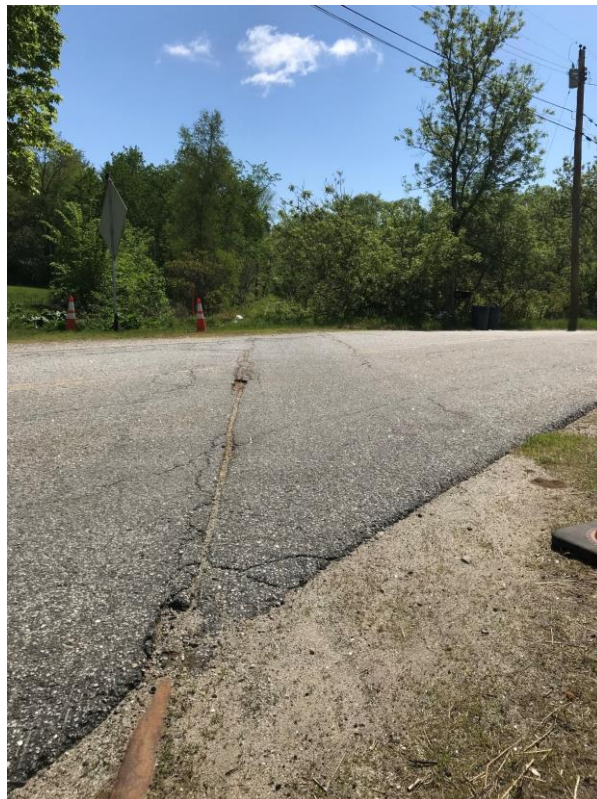
Photo 24. Old Lisbon Road Crossing.
Rail paved over.

Old Lisbon Road – The rail corridor crosses Old Lisbon Road at about a 45° angle just after a curve in the road way. If possible within the rail/roadway right of way, it would be desirable to design a corridor crossing at a 90° angle. Future improvements would include advance signage, trail bollards and on the road markings.

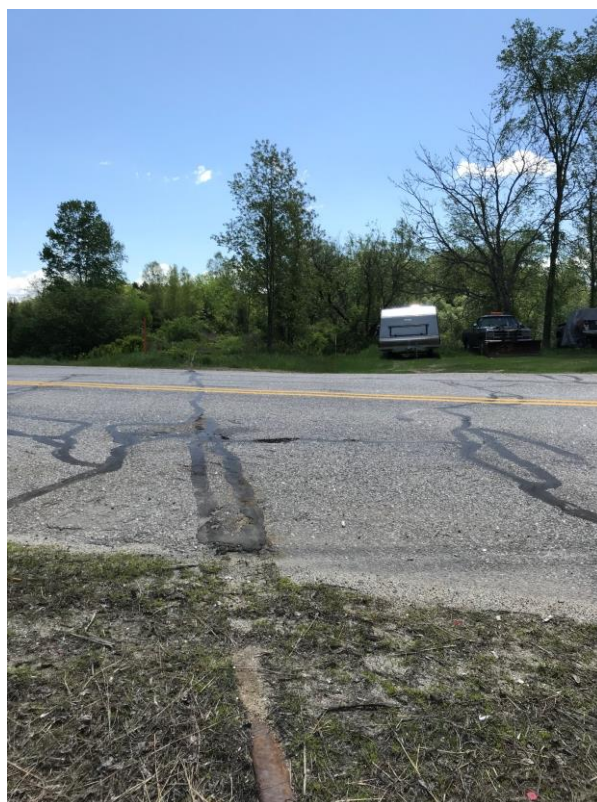
Photo 25. Crowley Road Crossing.
Rail paved over.

Crowley Road – The rail corridor crosses Crowley Road near a bridge over No Name Brook. The area of the crossing has good sight distance and overall visibility. A pedestrian/bicycle trail crossing should be designed to intersect the roadway at about 90 degrees. Future improvements would also include advance signage, trail bollards and on the road markings.

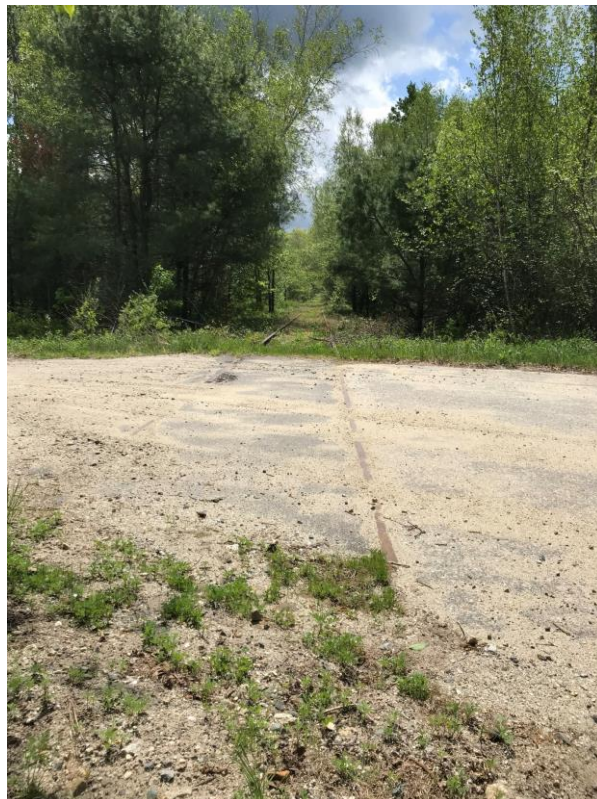
Photo 26. Jordan Road Crossing.
Rail paved over.

Jordan Road – This very narrow, rural roadway crosses the rail corridor at about a 45 degree angle. Sight distance is relatively good for what is a low speed, low traffic roadway. Rails are still visible and present within the road. Future improvements would include advance signage, trail bollards and on the road markings.

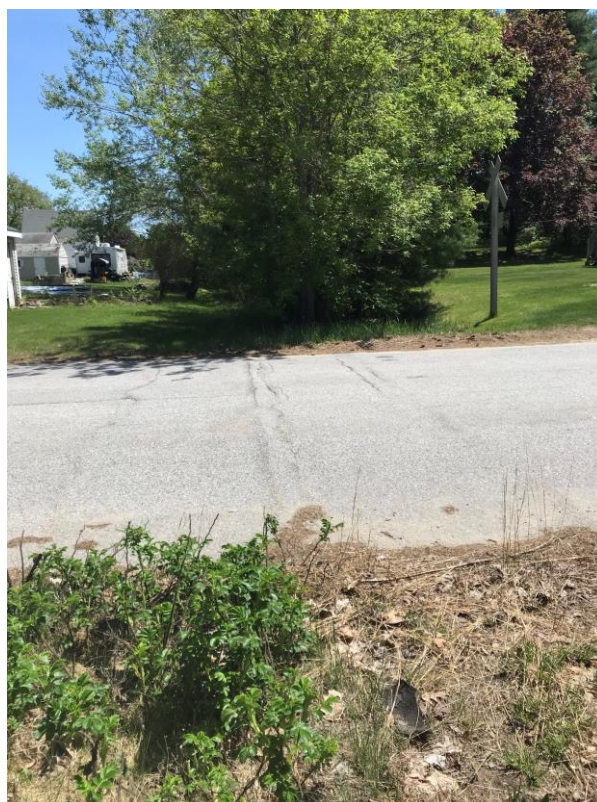
Photo 27. Winter Street Crossing.
Rail paved over.

Winter Street – After traversing close behind a number of residences the rail corridor crosses Winter Street at approximately a 90° angle. Sight distance along Winter Street is good for the posted speed. Future improvements would include advance signage, trail bollards and on the road markings.

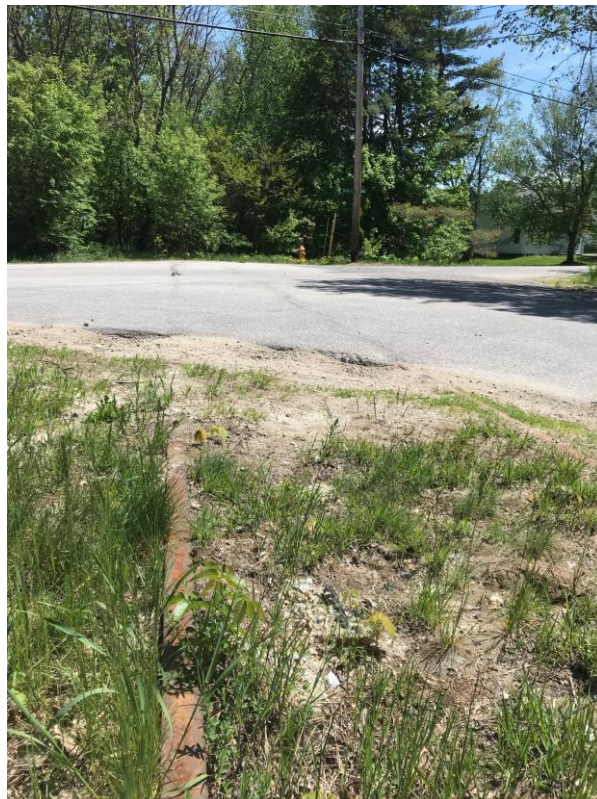
Photo 28. Village Street/Ferry Road Crossing.
Rail paved over.

Village Street/Ferry Road/Pinewoods Road – The rail corridor crosses the intersection of Village Street, Ferry Road and Pinewoods Road in Lisbon. Two tracks of rail are still present and visible in the intersection. The corridor crosses directly through the T-intersection of the roads. Accordingly, the design of a pedestrian/bicycle trail crossing would need to pay particular attention to both through traffic (Village Street) and stopped traffic (Pinewoods Road). Sight distance is good along both roadways. Future improvements would include advance signage, trail bollards and on the road markings.

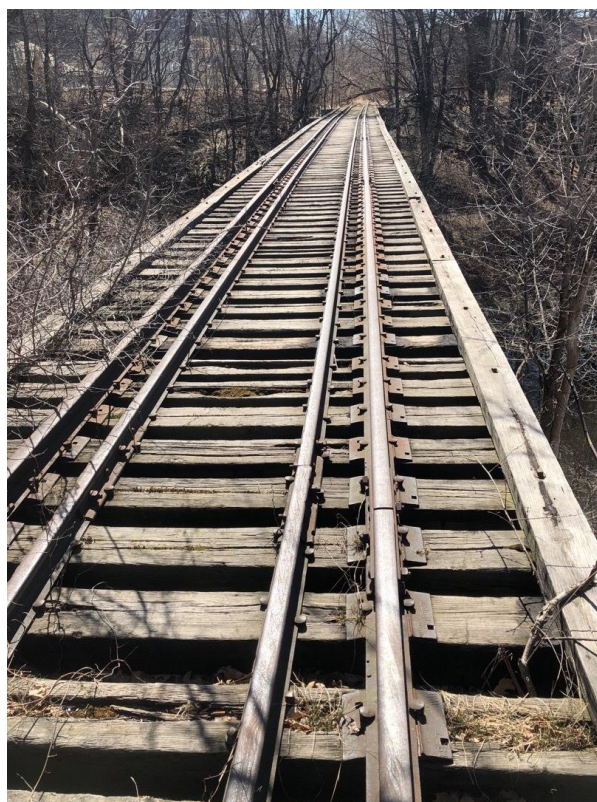
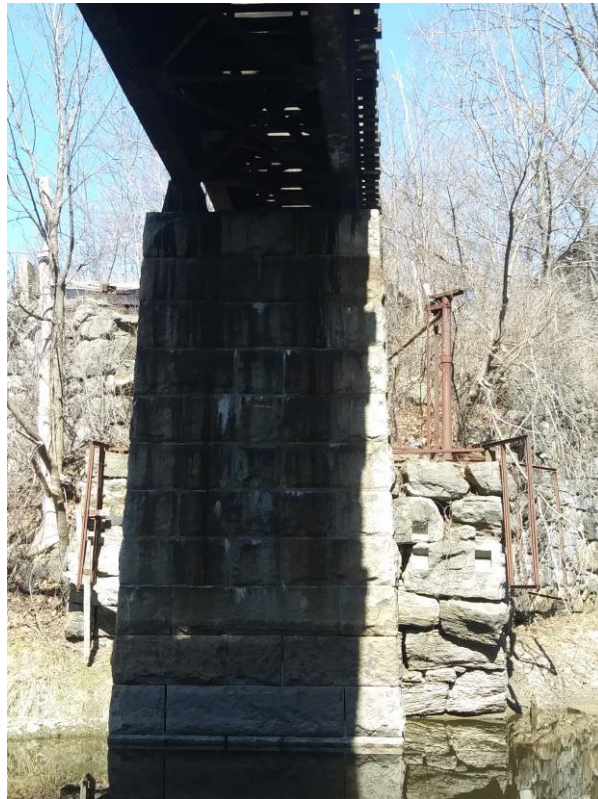
Androscoggin Mill Cross Canal (Bridge Crossing #1) – This bridge is the most significant along the rail corridor spanning more than 100'. It is supported by granite block abutments that rise high over the combination cross canal and streamway that serves as the outlet for the Upper Canal system. The channel empties directly into the Androscoggin River. The bridge is constructed of steel girders that appear to be in good condition. Ties currently supporting the rails are rotten in several areas and would need to be replaced. To be used as a pedestrian/bicycle bridge rails would need to be removed, ties replaced and some type of solid decking installed. Railings and a higher fence would also need to be installed due to the height of this structure.

Photo 29. Rail Bridge #1, crossing unnamed canal.
Scenic view of surrounding canal.

Photo 30. Rail Bridge #1
abutment and canal.

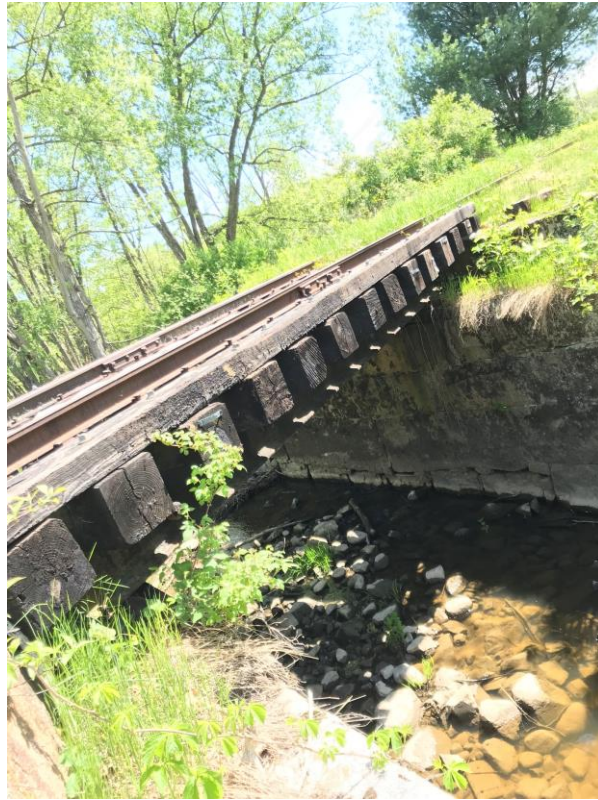
Crowley Road – West (Bridge Crossing #2) – This small bridge structure is located approximately 130' to the west of Crowley Road in Lewiston. The structure spans about 20' and is supported by concrete abutments. Some rail ties would need to be replaced and new decking installed for use as a pedestrian bridge.

Photo 32. Bridge Crossing #2 over stream west of Crowley Road.
Scenic area with adjacent wetland.

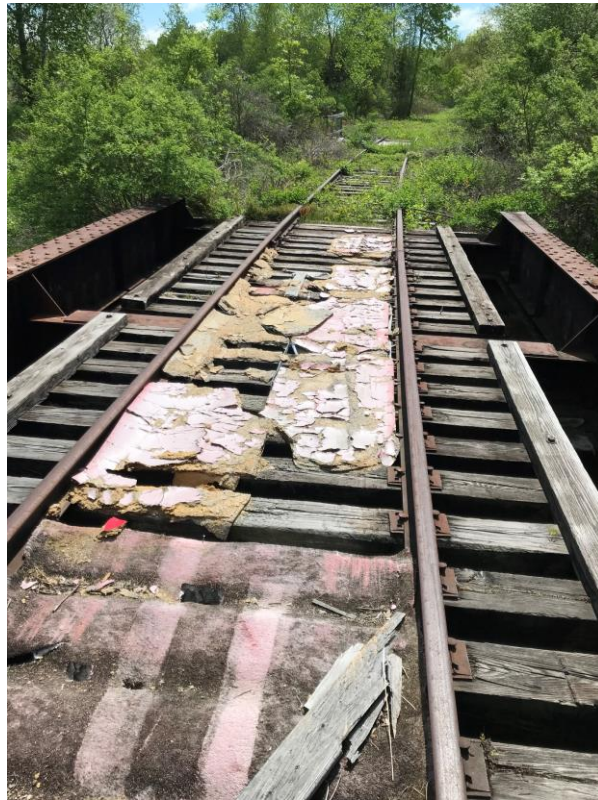
Crowley Road – East (Bridge Crossing #3) – This is a steel girder bridge located approximately 115' easterly of Crowley Road in Lewiston. It spans about 30' and rests upon granite block abutments.

Photo 33. Bridge crossing #3 over stream east Crowley Road.
Scenic area with adjacent wetland.

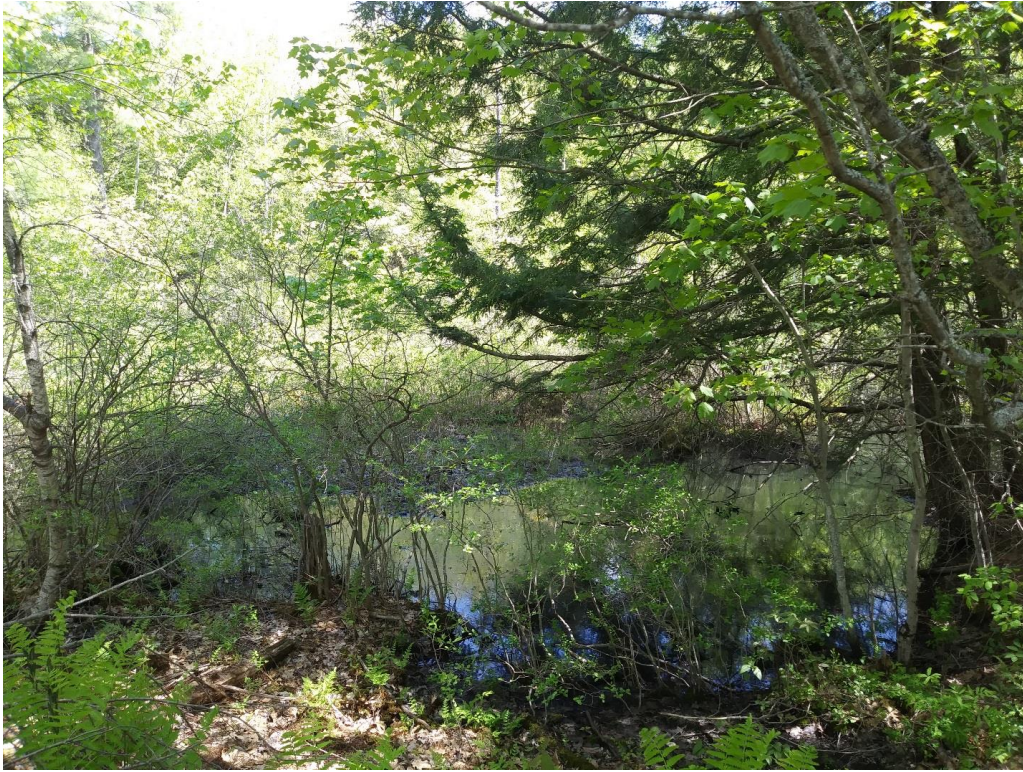
Photo 34. West of Crowley Road

Scenic pond and wetland area adjacent to rail bed. There is a trash pile near the pond.

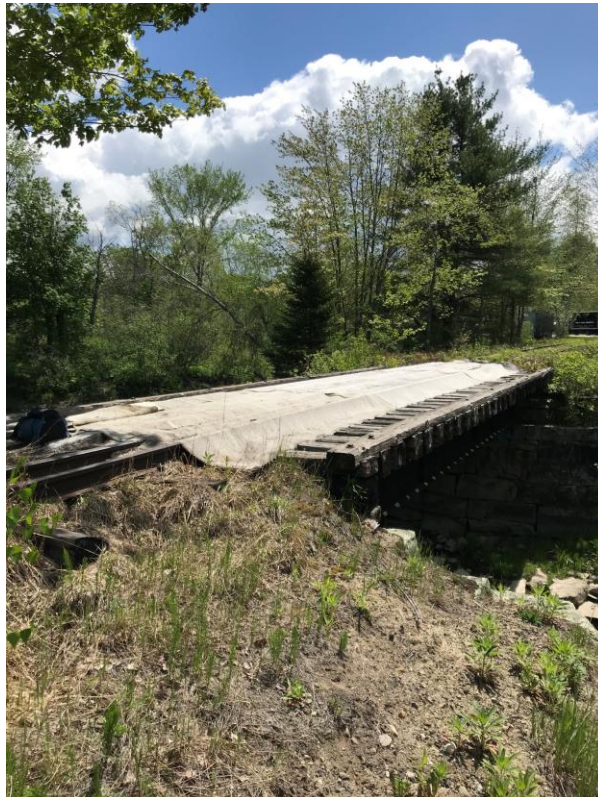
Photo 37. Bridge crossing #4 over No Name Brook.

No Name Brook (Bridge Crossing #4) – This bridge is located approximately 225' northwesterly of Rt. 196 just over the Lisbon town line. The bridge spans about 40' and shows signs of erosion around the abutments on either end. Rail ties would need to be replaced and decking installed.

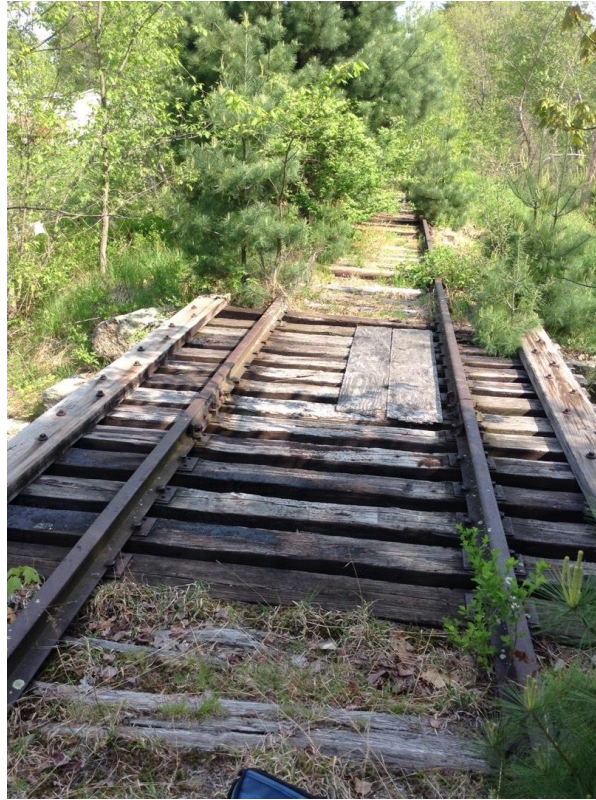
Whitney Street (Bridge Crossing #5) – This small bridge spans about 10'-12' and lies just east of Whitney Street in Lisbon. Ties on the land side of the bridge are rotten and in need of replacement. Rotten ties would need to be removed, replaced and decking installed for use as a pedestrian bridge.

Photo 40. Bridge crossing #5 near Whitney Street.
Scenic wetland and stream adjacent to rail.

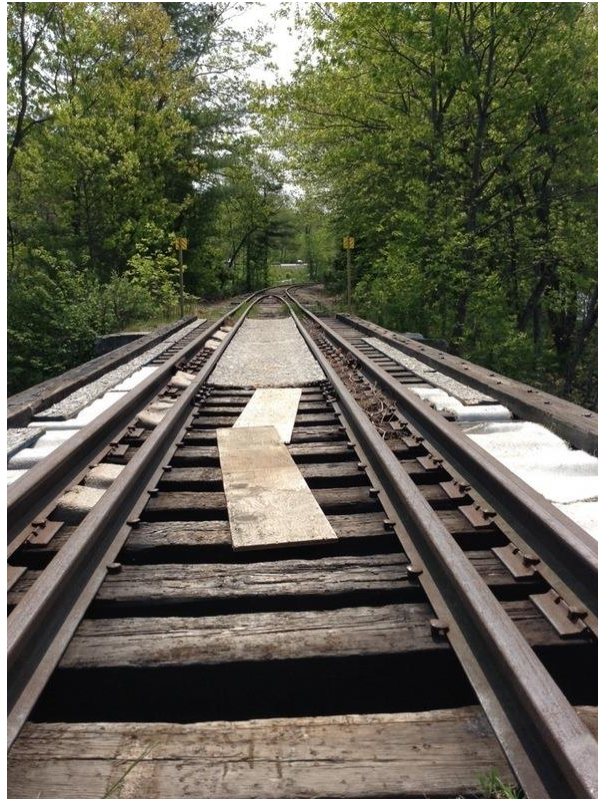
Sabattus River (Bridge Crossing #6) – This bridge crosses the Sabattus River at its outlet to the Androscoggin River. It is located approximately 90' parallel to the Rt. 196 bridge which also spans

the Sabattus River. It is a steel girder bridge supported by granite block abutments which appear to be in good condition.

Photo 42. Bridge Crossing #6 over the Sabattus River.
First scenic views of the Androscoggin River.
