**MOUNTAIN DIVISION
RAIL CORRIDOR**

Interim Trail Feasibility Study - Standish to Fryeburg

WIN# 026858.00

**SUBMITTED BY:
HNTB CORPORATION**

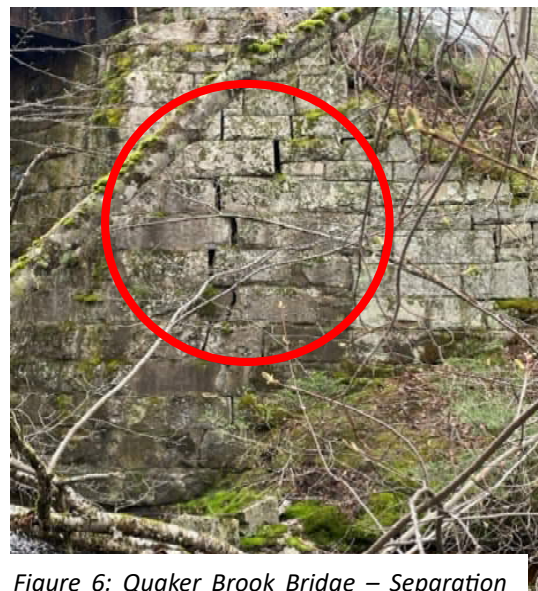
Figure 6: Quaker Brook Bridge – Separation Between Wingwall and Breastwall

MP26.04 – Quaker Brook (Bridge #7673): This bridge has a 33.5' span steel stringer superstructure with 10' wide ties supported by 30' tall stone masonry abutments. Both abutments show signs of failure at the breastwall/wingwall interface and wall stabilization with soil anchors, galvanized steel channels, and local mortar replacement is recommended. The timber deck has a condition rating of 4, 75% tie replacement is assumed. Bearings have not been inspected due to vegetation around the bearing, but bearing replacement is recommended as part of this bridge rehabilitation.

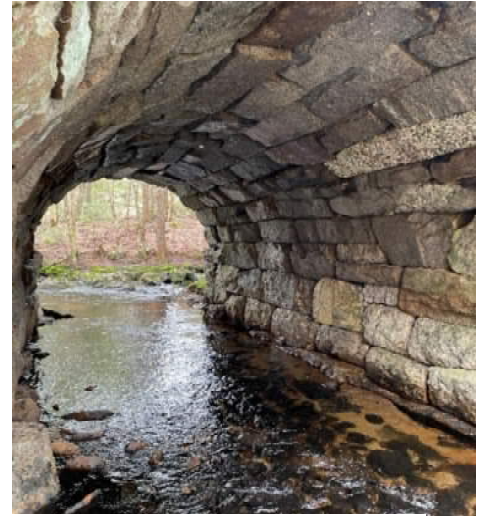
Figure 7: Pigeon Brook Bridge – Stone Arch Culvert Barrel

MP29.30 – Pidgeon Brook (Bridge #7674): This 12' span granite arch bridge appears stable, no signs of sagging or movement. Therefore, no repairs are anticipated as part of this project. Mortar is not visible in arch joints; however, it's likely this structure was constructed as dry-laid stone without mortar.

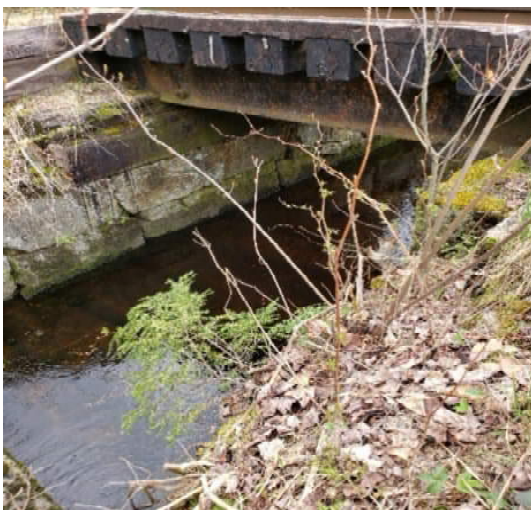
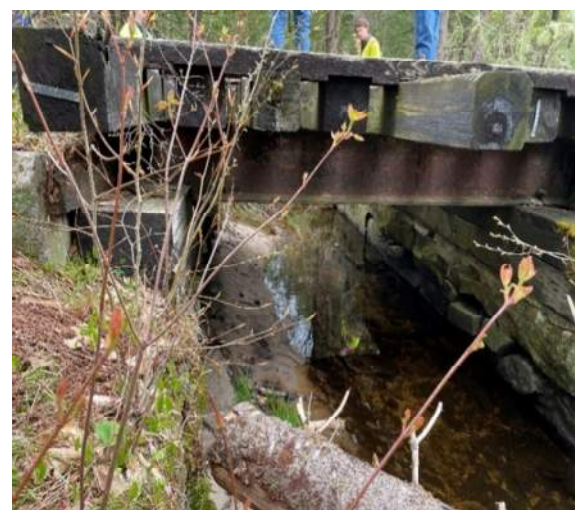
MP29.70 – Red Brook (Bridge #7675) & MP 30.39 – No Name Brook (Bridge #7676): These bridges each have 10' span steel stringer superstructures with 8' or 10' wide ties supported by 6' tall stone masonry abutments. Due to the low cost of replacing a short span, substandard tie width of the existing structures, and heavy mortar loss of the existing substructures, full replacement of both structures is recommended. Repair of large voids in the abutments requires cofferdams, and the combined cost of cofferdams and abutment mortar repairs is likely more expensive than bridge replacement. The recommended bridge replacements would have 30' span steel girder superstructures with timber decks supported by cross-laminated timber abutments founded on grade. Existing abutments would remain in-place as slope protection.

Figure 8: Red Brook Bridge – Stone Abutment with Timber Seat and Steel Stringers Arch Culvert Barrel

Figure 9: No Name Brook Bridge – Stone Abutment with Timber Seat and Steel Stringers Arch Culvert Barrel

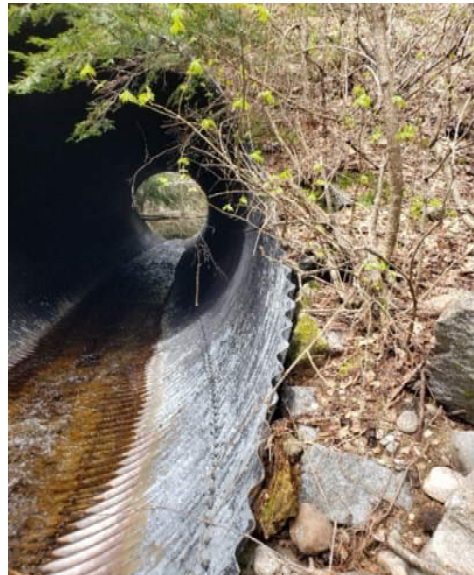
MP32.90 – Dug Hill Brook (Bridge #7686): This structure is a 16' diameter steel multi-plate culvert. The culvert has significant section loss along the invert and signs of undermining at the outlet. The recommended repair is to temporarily bypass flow in the culvert to replace undermined material and the installation of a concrete culvert invert lining.

Figure 10: Dug Hill Brook Bridge – Steel Multiplate Culvert with Rust Losses Along Culvert Invert

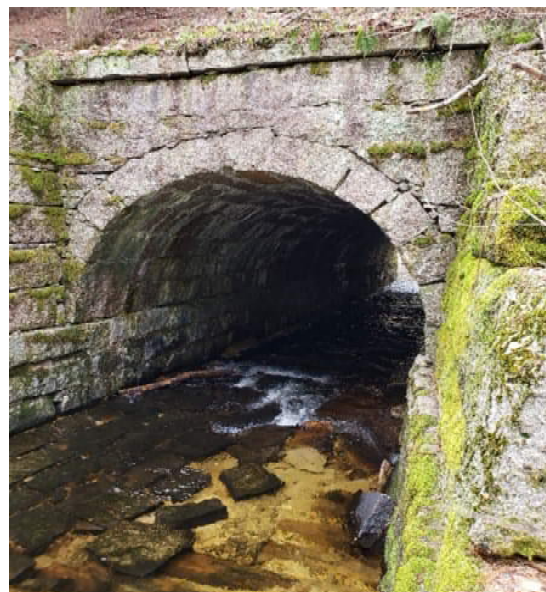
Figure 11: Break Neck Brook Bridge – Stone Arch Culvert Headwall

MP33.97 – Break Neck Brook (Bridge #7678): This crossing is a 12.5' span granite arch bridge. The bridge appears stable, no signs of sagging or movement, and no repairs are recommended. Mortar generally appears intact with widespread efflorescence.

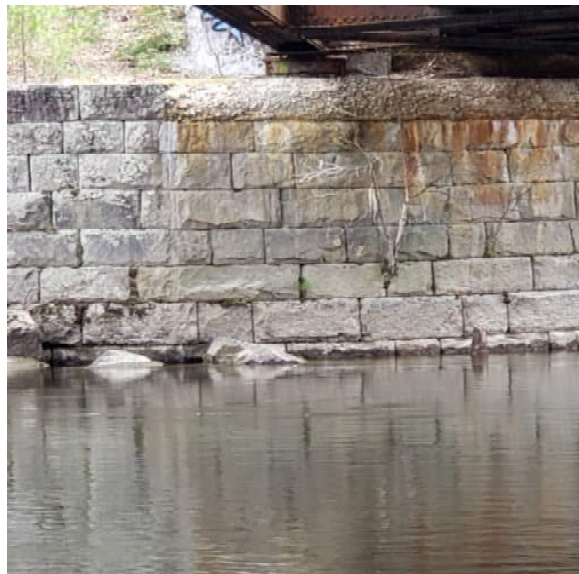
Figure 12: Saco River Bridge – Stone Abutment with Concrete Abutment Seat

MP36.32 – Saco River (Bridge #7679): This bridge has a 183’ span steel truss superstructure supported by 16’ tall mortared stone abutments with concrete caps. The concrete caps are heavily spalled and the joints between stones appear tight and even. No substructure repairs are recommended. The timber deck has a condition rating 4, 75% tie replacement is assumed.

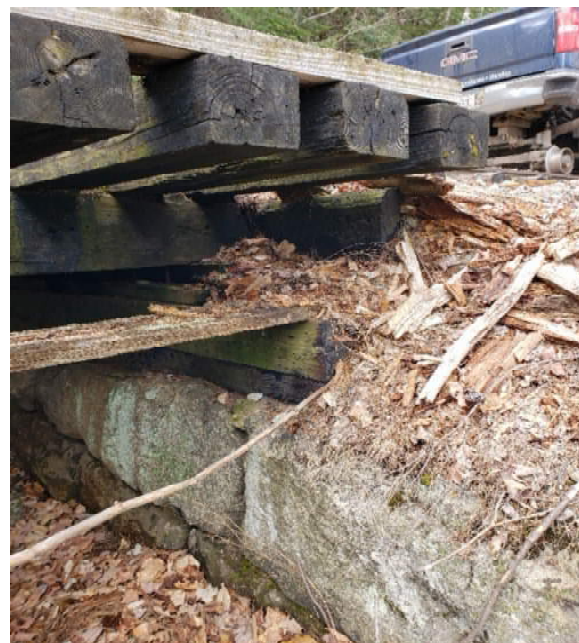
Figure 13: Cattle Pass Bridge – Stone Abutment with Timber Stringers and Ties

MP37.01 – Cattle Pass (Bridge #7685): This bridge has a 9’ span timber superstructure with 12’ wide ties supported by 6’ tall stacked stone abutments. Timber abutment seats, backwalls, and bearings have rot and replacement is recommended. The timber deck has a condition rating of 4, 75% tie replacement is assumed.

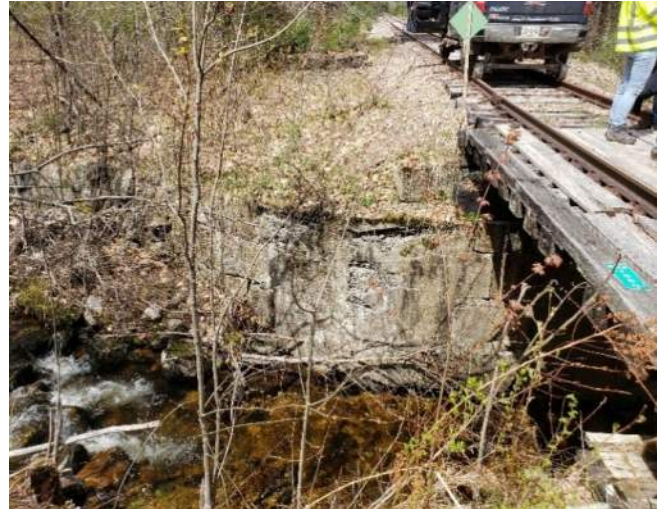
MP37.45 – Red Mill Brook (Bridge #7680):

This bridge has a 15.5' span steel stringer superstructure with 10' wide ties supported by 10' tall mortared stone and concrete encased stone abutments with timber abutment seats. Timber abutment seats, backwalls, and bearings have rot and replacement is recommended. The abutment undermining recommended repairs are grout bags. While concrete shows extensive cracks/spalls and mortar loss of the stone masonry, deferring these repairs is acceptable. The timber deck has a condition rating of 4, 75% tie replacement is assumed.

Figure 14: Red Mill Brook Bridge – Concrete Faced Stone Wingwall with Spalling and Undermining Ties

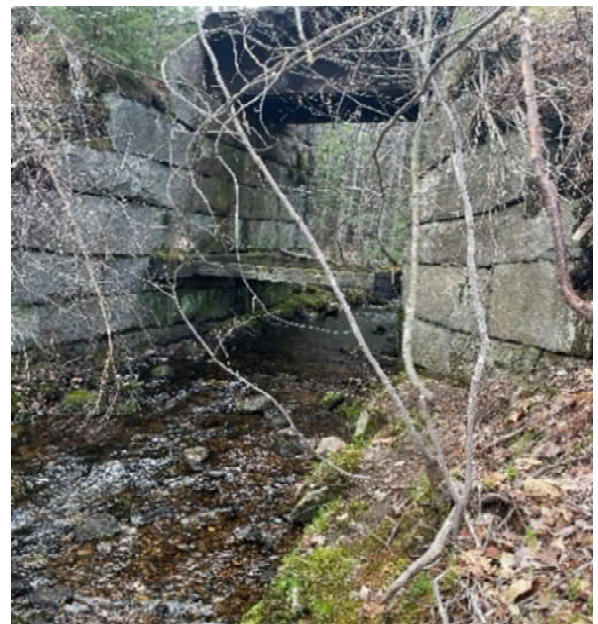
Figure 15: Pierce's Brook Bridge – Stone Abutment with Timber Strut Supports

MP38.67 – Pierce's Brook (Bridge #7681): This bridge has a 15' span steel stringer superstructure with 10' wide ties supported by 15' tall stacked stone abutments with no visible mortar with timber bridge seats. The abutment breastwalls exhibit signs of instability: the abutments are leaning generally inward; stone courses are uneven and individual stones protrude from the course of stones. Additionally, a timber punch previously installed to stabilize the abutments is displaying signs of rot and section loss. The installation of soil anchors with galvanized steel walers is recommended to provide widespread stone stabilization of the abutments. Timber abutment seats, backwalls, and bearings have rot and replacement is recommended. The timber deck has a condition rating of 5, 35% timber tie replacement is assumed.

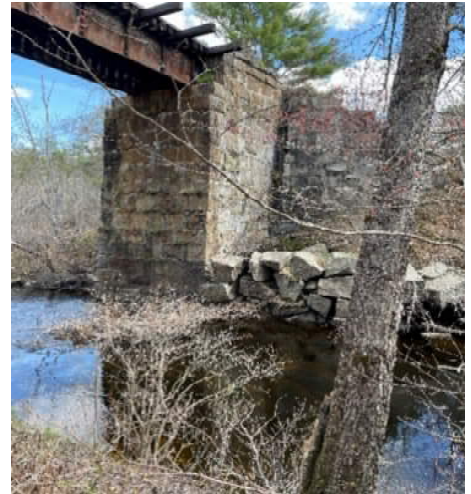
Figure 16: Ten Mile Brook Bridge – Stone Abutment with Return Wingwalls and In-Line Wingwalls

MP41.06 – Ten Mile Brook (Bridge #7682): This bridge has a 45’ span steel stringer superstructure supported by 35’ tall mortared stone abutments. The abutment breastwalls appear straight and stable with some mortar loss; therefore, no substructure repairs are recommended. There is evidence of past instability of the structure. The southwest retaining wall has two soil anchors installed to support visibly shifted stones and the southeast in-line wall shows stone separation that has been filled with large mortar repairs. Replacement of the existing bearings is recommended. The timber deck has a condition rating of 5, 35% tie replacement is assumed.

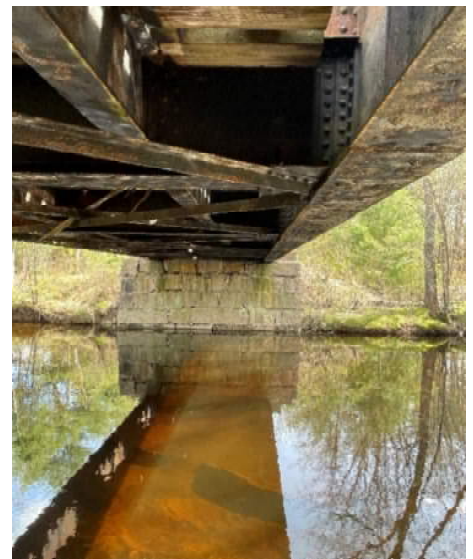
Figure 17: Shepard’s Brook Bridge – Stone Abutment and Bottom of Steel Through Girder Superstructure

MP43.76 – Shepard’s Brook (Bridge #7683): This bridge has a 56’ span steel through-girder superstructure with 12’ wide ties supported by 10’ tall stacked stone abutments. The abutment breastwalls appear straight despite mortar loss., No substructure repairs are recommended as part of this project. The existing timber bearings are showing signs of rot; replacement with steel-reinforced elastomeric bearings is recommended. The timber deck has a condition rating of 4 and the timber ties have char/section loss resulting from a fire. Complete replacement of the timber ties is assumed.

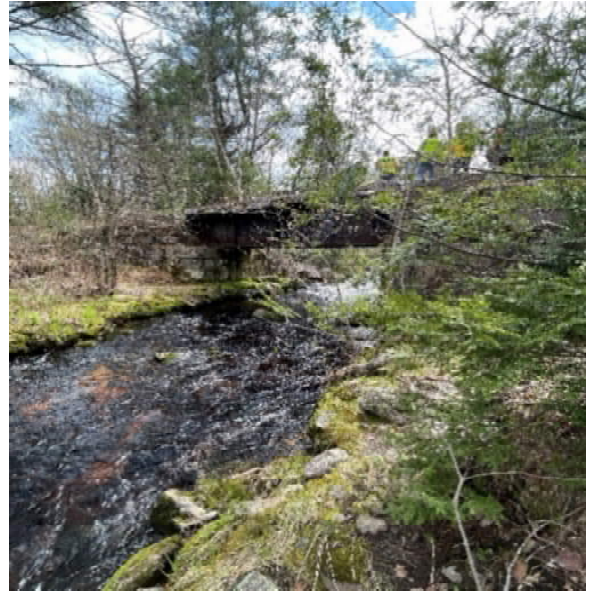
Figure 18: Little Saco River Bridge – Stone Masonry Abutment and Steel Girder Superstructure

MP46.27 – Little Saco River (Bridge #7684): This 28' span steel stringer bridge with 10' wide ties supported by 6' tall stacked stone abutments with scattered mortar loss. Abutment breastwalls appear straight, therefore no substructure repairs are recommended as part of this project. The timber deck has a condition rating of 5, 35% tie replacement is assumed.
